Dendrochronologia 24 (2007) 69–78

ORIGINAL ARTICLE

Dendrogeomorphological analysis of shore erosion along Bolsena lake (Central Italy)

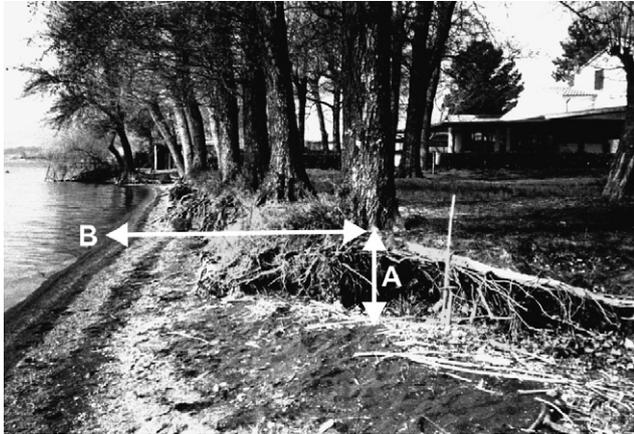
Fig. 2. Tree morphology survey: “erosion step” (height from root collar and actual shore level) and distance of tree from shoreline (B).

A careful morphological examination of each sample tree was conducted whereby the “erosion step” (= axial length of exposed root system due to erosion; measured from the root collar to the actual shore level) (A) and the distance of the stem from the shore taken from the middle of tree trunk (B) (Fig. 2). The distance

of the trees from the shore (B) were recorded in the same week to avoid variations due to lake-level fluctuation. This analysis of the morphology of trees, in particular of the erosion step, was used to develop a map of erosion along the entire coastline of the Bolsena lake.
